Technological assessment of laparoscopic monopolar electrosurgery instruments at CSSS du Lac-des-Deux-Montagnes

Gnahoua Zoabli¹, Geneviève Foley², Pierre Cadieux¹, Éric Perreault¹, Sylvain Pomerleau¹ et Frédéric Ouellet¹

¹CSSS du Lac-des-Deux-Montagnes, St-Eustache, Québec;

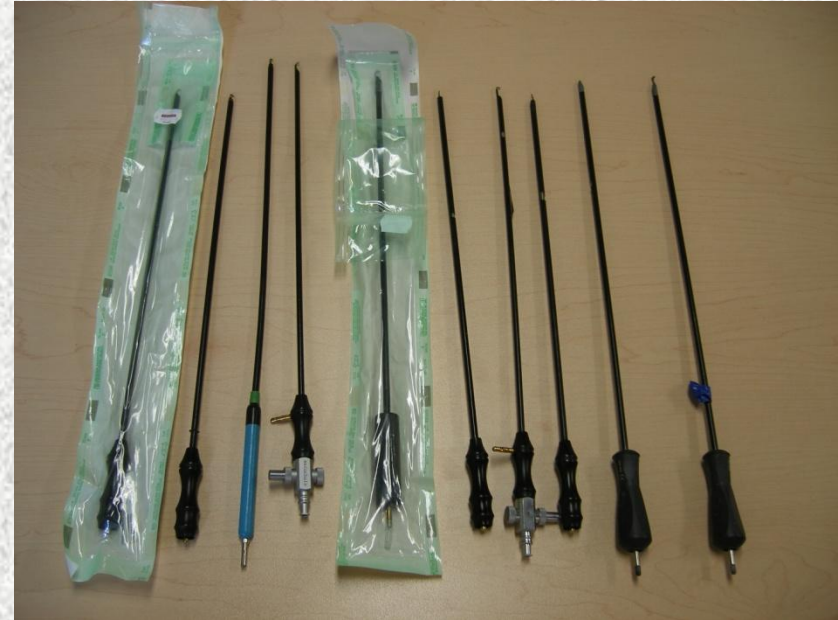
- *Duration: 2 months during which single use devices are purchased*
- *Laparoscope assessment was limited to 8 electro-surgical hooks and 2 spatulas*

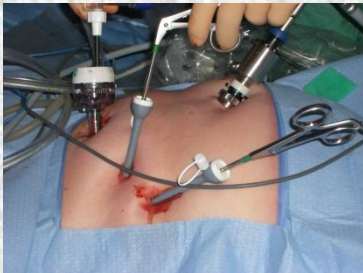
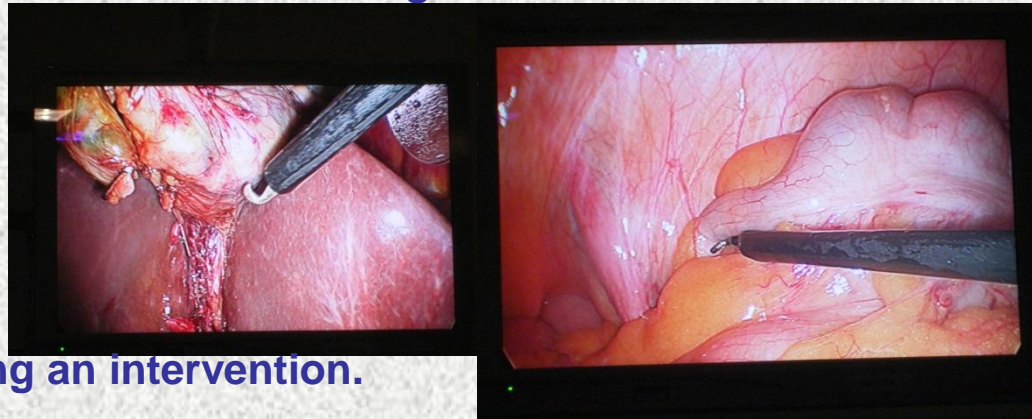
Instrument handling and wear

- Two members of the biomedical engineering department witnessed a laparoscopic cholecystectomy to observe the normal usage of the instruments.
- Observations focused on contact between internal organs and instruments during cauterization (local zoom)

- Normal wear of instruments during an intervention.
- Friction of the laparoscope during its insertion into the trocar is also observed for resulting in potential mechanical damage.
- The number of procedures done with each instrument is unknown (no traceability system for surgical instruments)
 - *This information could have helped to determine if normal insulation wear led to the reported incidents.*

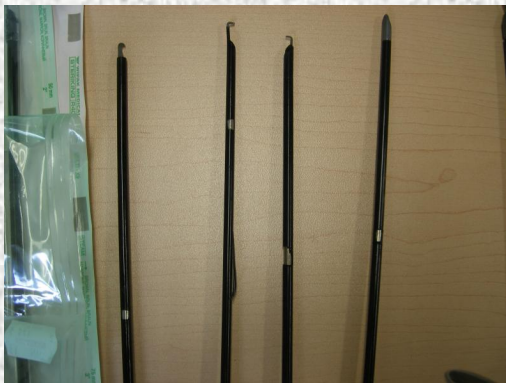
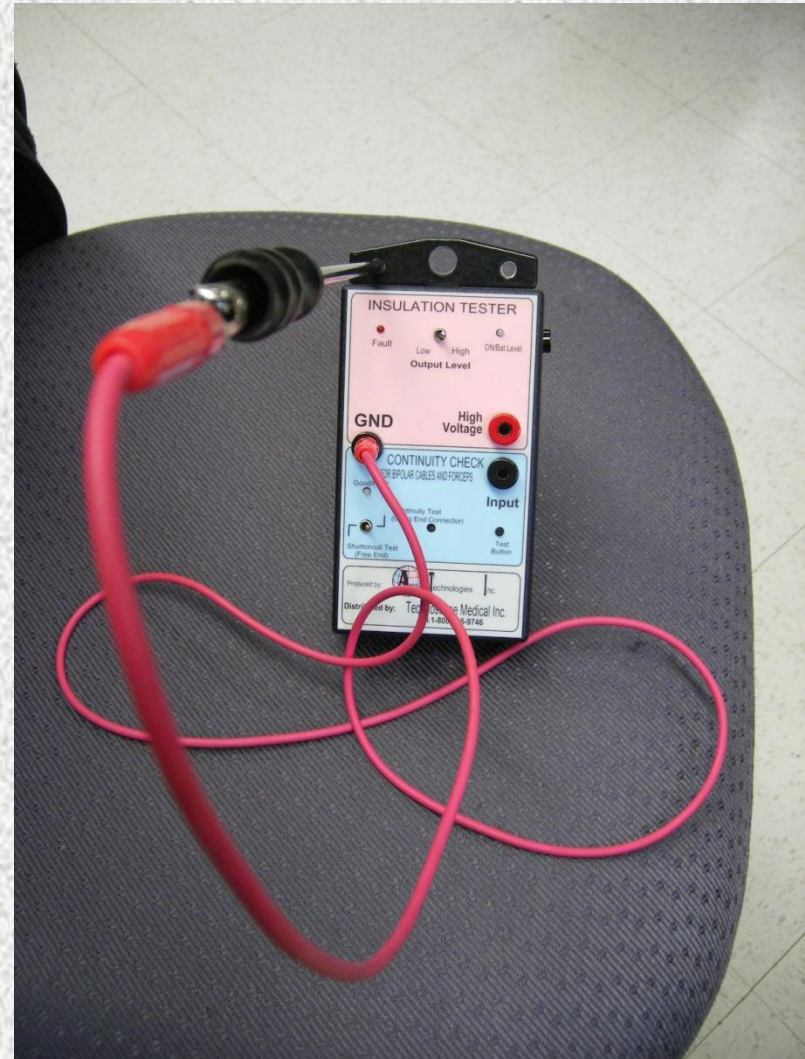
Electrode insulation testing

- Insulation layer was tested with an insulation tester (Atlas Technology Inc., ATI-013)
 - *A beep indicates a leakage if any*
- Only four (4) models of instruments tested for isolative sheathing thickness measurement
 - *3 surgical hooks*
 - *1 spatula*

- A few designs were considered to test the insulation of laparoscopes before every sterilization cycle.
 - Even though only the distal third of the instruments would need to be verified, none of the designs were simple and efficient enough to ensure it could **be successfully added to the nursing staff's workload**.

- The major issue in optimizing insulation testing is the need to insulate the tip of the electrode in order to test exclusively the insulative sheathing.

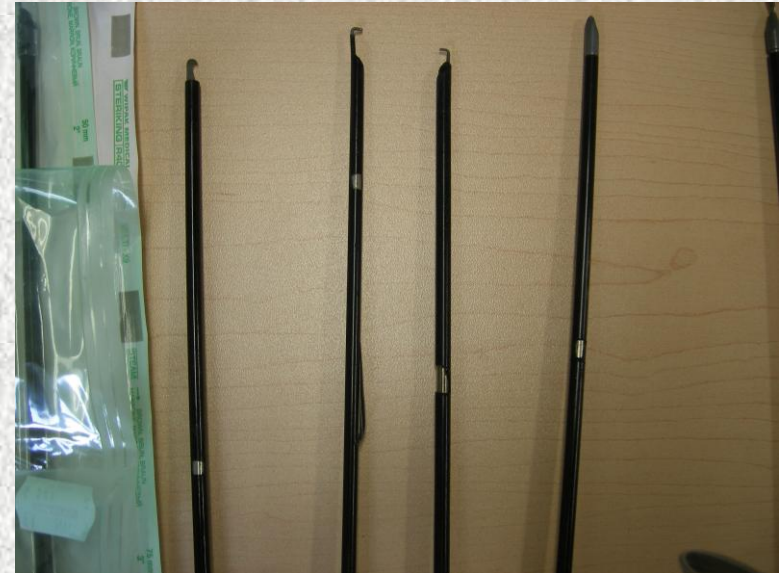
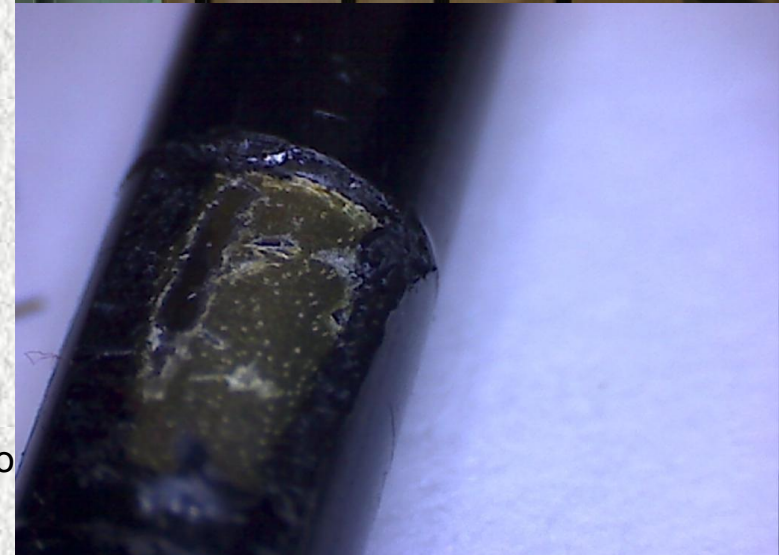
Isolative sheathing thickness measurement

- Among the ten reusable instruments, four models of laparoscopes (3 hooks and 1 spatula)
- A section of the insulation material was removed on a limited mid-to-distal portion of the diameter of the laparoscope
 - *representing the area outside the field of view and outside the trocar*
 - *possibly in contact with surrounding organs*
- Insulation thickness was defined as the difference, measured by a caliper, between the unaltered instrument and the section missing a portion of insulation material

- *Insulative sheathing thickness*
 - Insulation layer thickness for the four tested instruments were of **0.27 mm, 0.39 mm, 0.49 mm and 0.53 mm**. The model involved in the incidents has the thinnest insulation thickness (**0.27 mm**).

- is almost half the thickness of the thickest layer (0.53 mm)
 - sheathing thickness is critical in assuring patient safety.
 - **A thicker (≥ 0.4 mm)** and more flexible insulative layer would reduce the probability of electrical breakdown when the instrument heats up from the flow of high intensity current.
